# Mapping of Alue Ubay Irrigation Area Infrastructure in Paya Bakong Sub-districts Aceh Utara Regency

**ABSTRACT--** *The Alue Ubay Irrigation area which has an irrigation network system consists of a fixed bendung, a primary channels, secondary channels and a disposal channel. Alue Ubay Irrigation area most of the infrastructure is almost 30 years old, so the condition of the building has begun to break down in many places. Research is conducted only on the primary channel as well as building divide/tapping into the existing one in each space. The purpose of this research is to educate the conditions and functions of the irrigation network, especially on the primary. The method used in this research is to merge between the data on the infrastructure condition in the field with other supporting data. The data required in this research are primary data that by conducting surveys and observations, identifying the physical condition of the field and the impact of damages and with interviews involving elements of the relevant agencies, secondary data Obtained from the technical data of Alue Ubay irrigation area and information from related agencies. The result of the assessment obtain

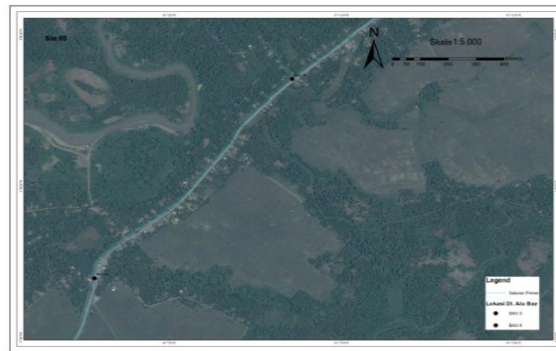
**Figure 1:** Irrigation Network Map Display

The data displayed on the map can provide information about the conditions and functions of the Alue Ubay Irrigation regional primary network. Such Data is the location of a breakdown, damage or condition of the channel and visual photograph of the field that can inform the damage condition of a location on the primay network.
