Failure Analysis of LP Turbine Final Stage Blades of High Capacity Power Plants

V.S. Thiagarajan and V. Jose Ananth Vino

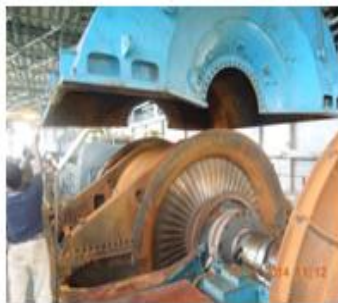
LP Turbine dismantling for inspection

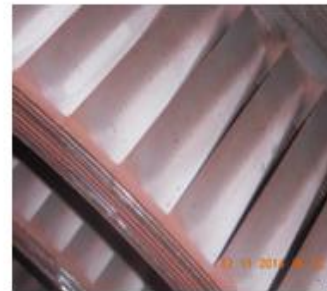
chlorine scale formation

- **To avoid corrosion due to chlorine:** Turbine wet steam washing can be introduced to clean the cl scales.

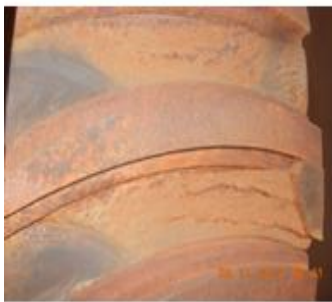
Blade crack at Root

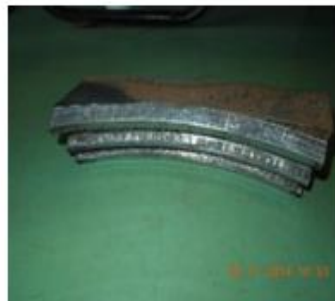
Failed Turbine blade Root

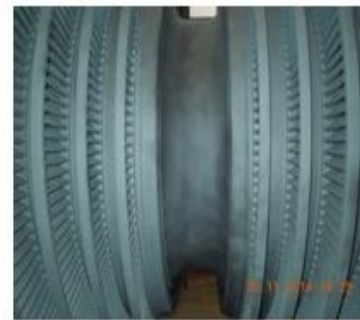
Turbine Rotor after Alumina Blasting

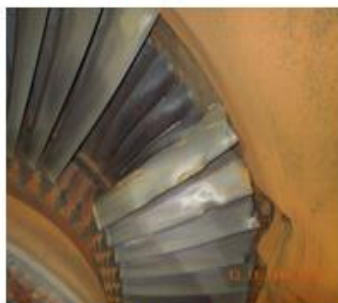
Damaged LP Rotor Final Stage Blades

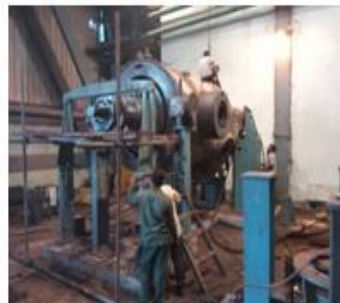
HP Turbine dismantling

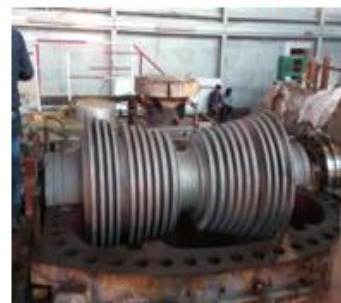
IP Turbine Dismantling

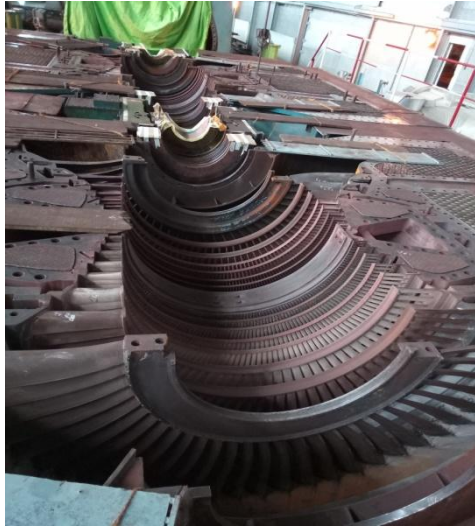
LP Turbine Bottom Fixed Blades

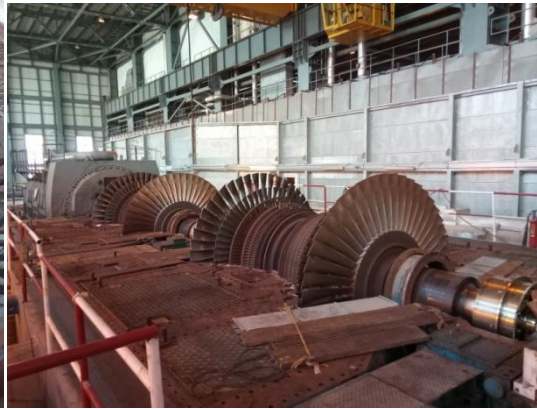
Both LP1 & LP2 turbine rotors placed condition
